AFRL-ML-TY-TR-2004-4547

Live Fire Evaluation of the Expeditionary Fire Suppression System (EFSS); Phase I

1. REPORT DATE (DD-MM-YYYY) 12/07/2004		2. REPORT TYPE Technical Report		3. DATES COVERED (From - To) 01-07-2003 to 01-08-2003	
4. TITLE AND SUBTITLE PhaseI: Live Fire Evaluation of the Expeditionary Fire Suppression System (EFSS)				5a. CONTRACT NUMBER F08637-03-C-6015	
				5b. GRANT NUMBER

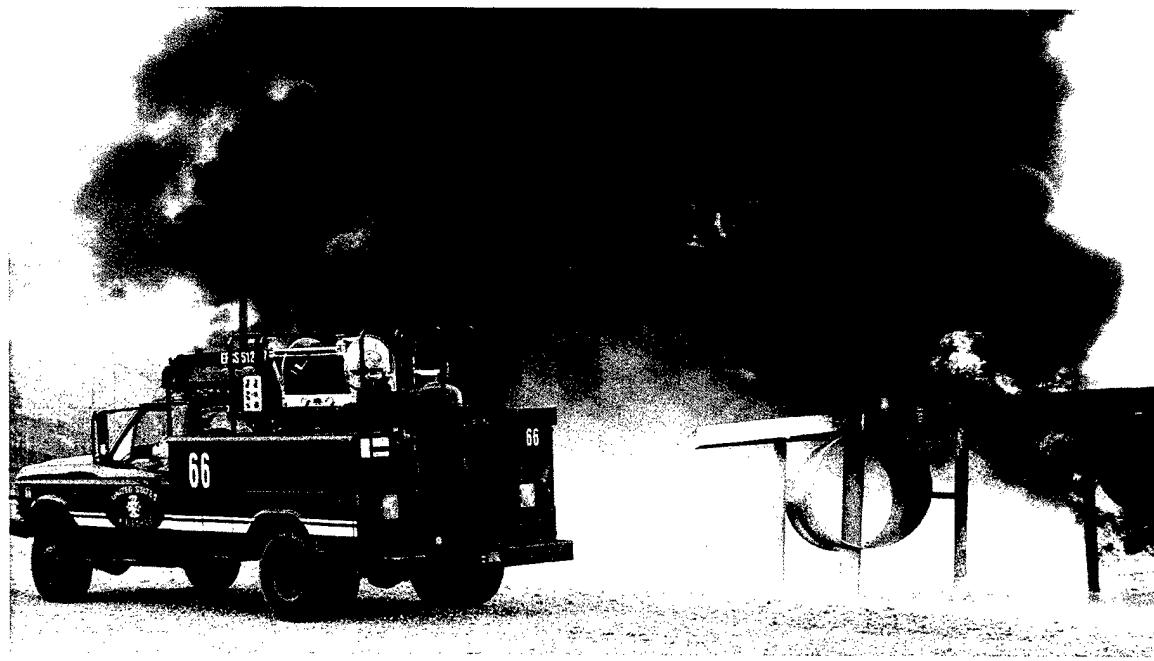
During Test 2E, the EFSS functioned normally and no problems were observed. The preburn time was 83.66 seconds and the extinguishment time was 56.37 seconds (Table 9). Figures 3 and 4 show the roof turret in operation during a half pit pool fire. The combination of foam and dry chemical provide superior knockdown compared to using either agent alone. The dry chemical provides good initial knockdown while the foam extinguishes, cools and prevents burnback.

Figure 3. 3500 ft² JP-8 Pool Fire using the EFSS Roof Turret.

Figure 4. EFSS Fighting Hydrocarbon Pool Fire with Roof Turret.

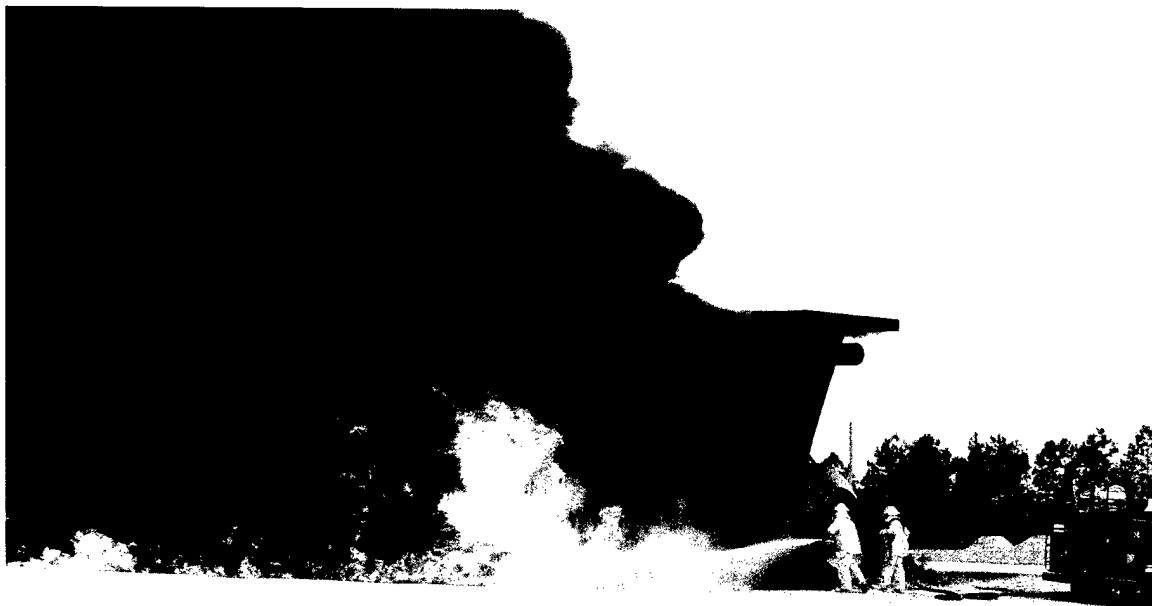
During Test 4B, the EFSS functioned normally and no problems were observed. The preburn time was 85.44 seconds and the extinguishment time was improved to 93.47 seconds (Table 14). Figures 5 and 6 show the handline operations on the 7000 ft² pool fires.

Figure 5. 7000 ft² JP-8 Pool Fire Using the EFSS Handline.

Figure 6. Handline Operations Using the EFSS Combined Agent System.

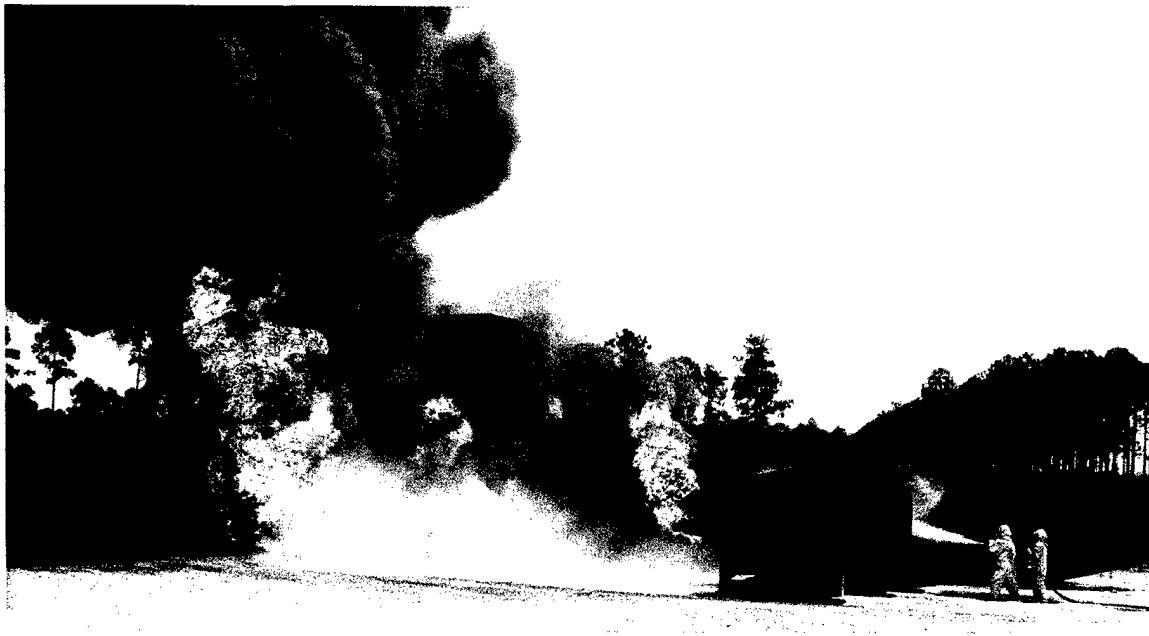
Figure 10. EFSS Handline Used to Extinguish F100 Fire From the Front of the Engine Nacelle.

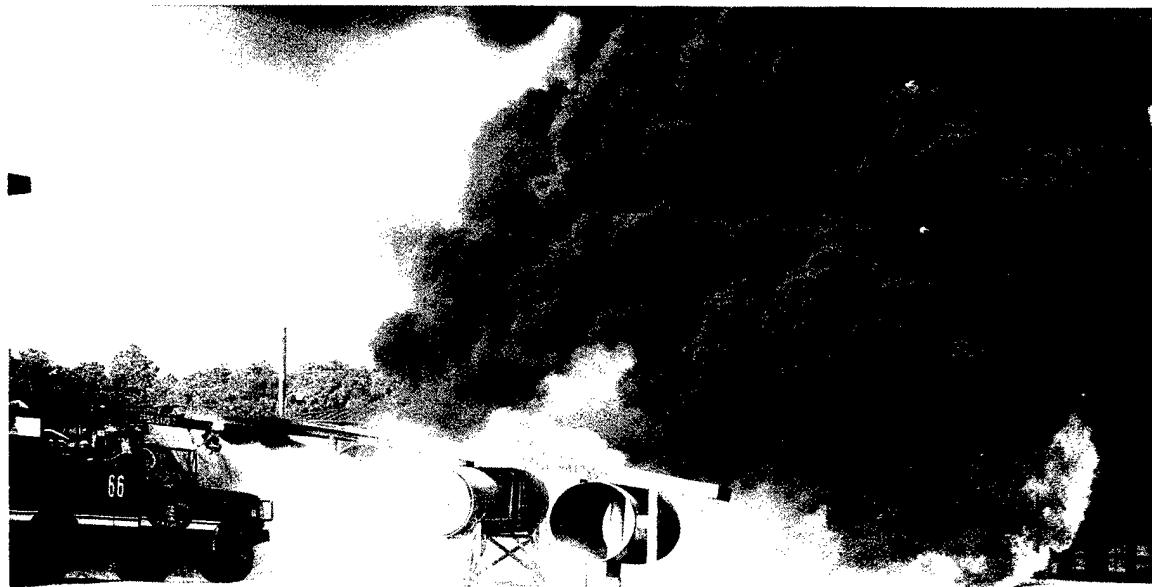
During Test 6C, the EFSS functioned normally and no problems were observed. The preburn time was 186 seconds and the extinguishment time was 93.66 seconds (Table 21). The extended preburn time was due to burn off of the residual foam in the pit from the previous test. Figure 11 and 12 show the EFSS using the roof turret to extinguish the F100 engine nacelle.

Figure 11. EFSS Roof Turret Extinguishing Combination Pool and Running Fuel Fire.

Figure 12. EFSS Roof Turret Extinguishing F100 Engine Fire.
